Ceiling Fans Case Study

Energy retrofits of a senior living facility show how ceiling fans integrated with air conditioning can deliver thermal comfort improvements and energy savings for community housing.

FRANCO CENTER

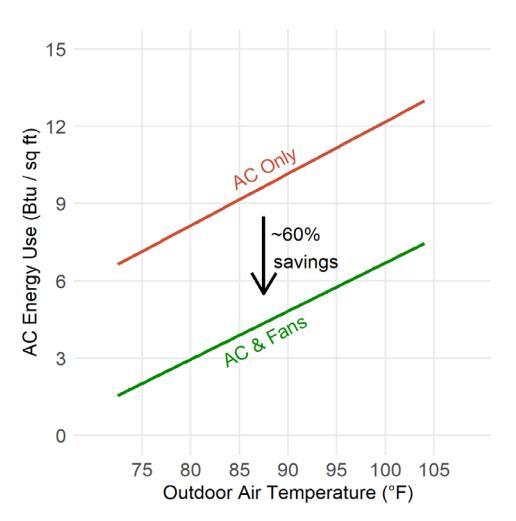
Figure 1. HVAC energy use in the common room was reduced by 60% by raising setpoints and using fans to cool occupants when the temperature was above 74 °F. Source: Dana Miller.

The first-floor common room is served by two compressors and nine fan coil units with a total capacity of approximately 400 MBtu/hour. Cooling setpoint temperatures were increased by 5-8 °F to 76 °F after the ceiling fans were installed. Electricity-monitoring equipment established baseline energy use before and after the fan installation. Measurements over two summers (Figure 1) show air conditioning energy use increased with outdoor air temperature as expected. The same relationship was seen after installing the ceiling fans, but the total energy use decreased by approximately 60% on average. This saved approximately \$1000 per month in electricity during summer. These savings were achieved by extending the temperature deadband, made possible by coordinating the fans and air conditioning to maintain or improve comfort.

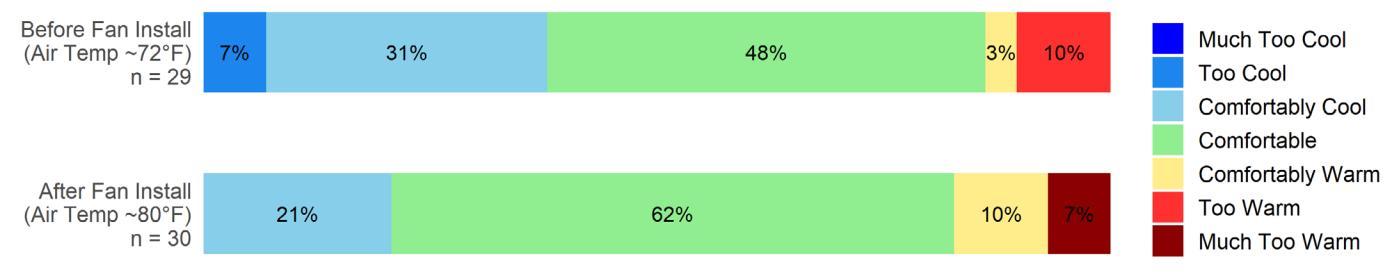
Figure 2. Over 90% of surveyed occupants in the Franco Center Apartments rated their indoor environment as "comfortable" after the ceiling fans were installed. This is an increase in occupant comfort from the earlier survey even though it was 8 °F warmer. Source: Dana Miller.

Thirty-five ceiling fans were installed in the common room in a grid arrangement to ensure even distribution of air speeds. They were programmed to start at 74 °F during occupancy, while the air conditioning was changed to start at approximately 76 °F. Thermal comfort surveys were completed by occupants before and after the ceiling fans were installed. Figure 2 shows 92% of surveyed occupants reported being comfortable at 80 °F with the ceiling fans running. This is an improvement in thermal comfort over the earlier survey without the fans, even though the temperature in the common room was 8 °F warmer. This demonstrates that cooling setpoints can be higher while providing similar or improved occupant comfort by using efficient ceiling fans, substantially reducing energy use and cost.
